Long Meadow Report

6/17/13-6/19/13

Intern Team: Cooper Collins, Nora Steadman, Jordyn Kohanamoku, Matthew Trenk

To locate and document any sign of anthropogenic impacts (specifically cattle) on the ecosystem of Long Meadow in Sequoia National Forest.

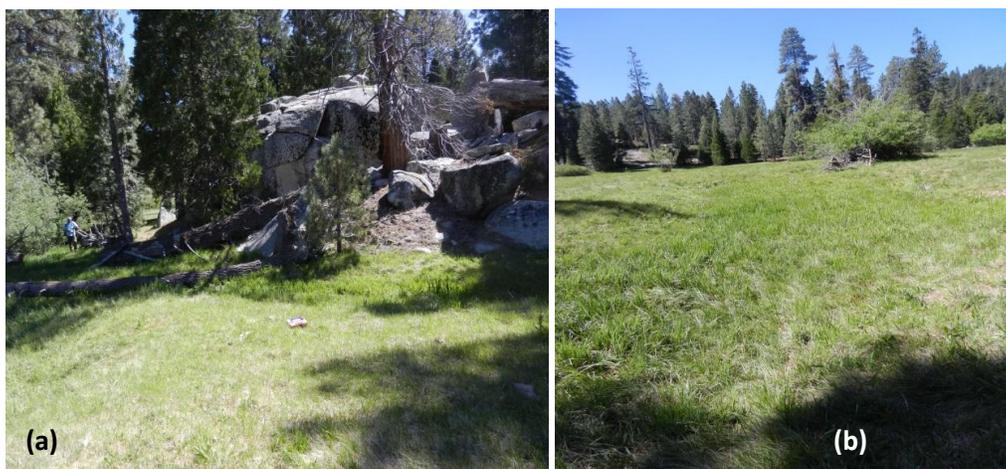
Figure 1: northern section of Long Meadow showing a species of water-adapted vegetation. The vegetation in (a) grows in the shade while the vegetation in (b) grows in damp soil.

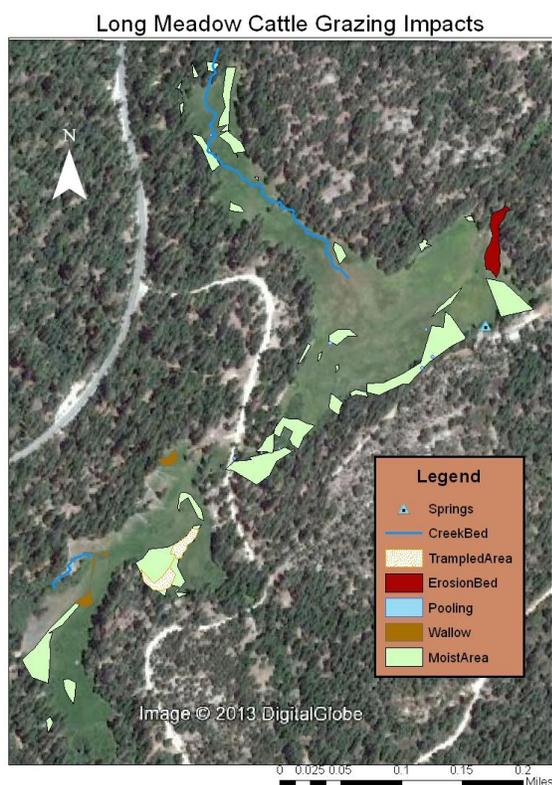
Figure 2: map of Long Meadow showing the creek bed and cattle grazing impacts

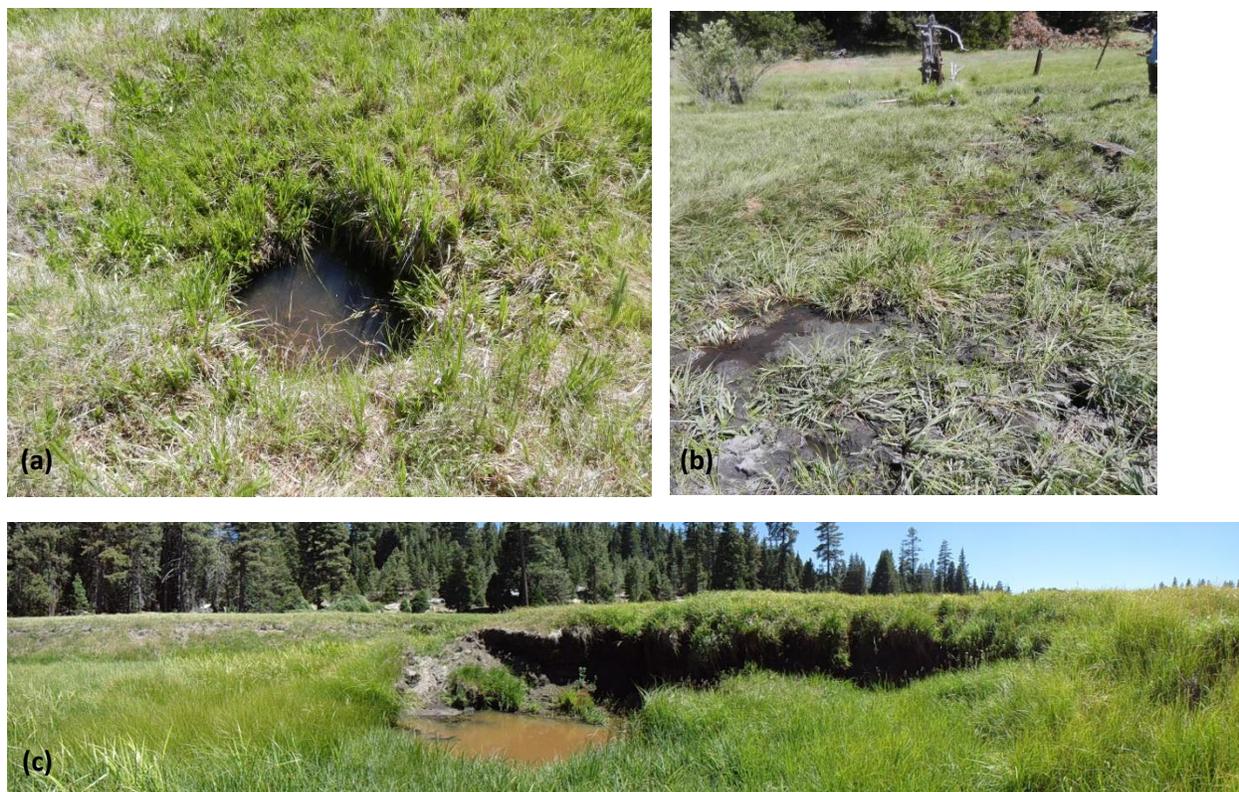
Signs of cattle intrusion were pervasive throughout both sections of the meadow. A number of wallows and cattle tracks were documented in the south section, of the meadow (Fig. 3a). Water adapted vegetation surrounded the wallows, which had damp soil and were waterlogged (Fig. 3b). In the eastern edge of the north section, a large eroded portion of the meadow, approximately 2 m deep and an area of 500 m² that showed evidence of cattle presence acted as a reservoir for a nearby spring (Fig. 3c). Cattle dung was prevalent in both sections.

Figure 3: instances of vegetation type conversion around cattle trampling, one near wallows (a) one near moist soil (b), and a large erosion bed 2 m deep (c).

There was very little water in the eroded bed in the north section, which could be caused by a low water table, creating a shift in the vegetation in the meadow at large. The presence of wallows also contributes to vegetation type conversion. Water adapted vegetation surrounds any area that has standing water and moist soil.

As the water table continues to drop, the meadow will dry at an accelerated rate, and the surrounding forest will begin to out-compete the graminoids and forbs which currently dominate the site. The meadow will also begin to be down-cut by seasonal water flow through the establishing creek bed.

land management activities (like grazing). These stream channel types are typically channels within mountain meadows and high elevation meadows without defined channels. Unstable-Sensitive-Degraded channels result from severe alteration of the Stable-Sensitive type. Gullies and altered (down-cut) meadows make up the bulk of these types on the Forest. Recovery usually requires active restoration measures³. At the very least removal of the cause of the severe alteration to meadows, which in most cases is livestock, is the best long-term solution for restoring meadows. Sites with more resilient substrate in less delicate areas should be considered for future cattle allotments.
